**Little Weiser River Stream Bank Protection and  
Rehabilitation  
Project  
Phase I Sub-Grant S247  
Final Report**

Prepared by:  
Adams Soil and Water Conservation District  
In Cooperation with:  
Idaho Soil and Water Conservation Commission  
Idaho Department of Environmental Quality

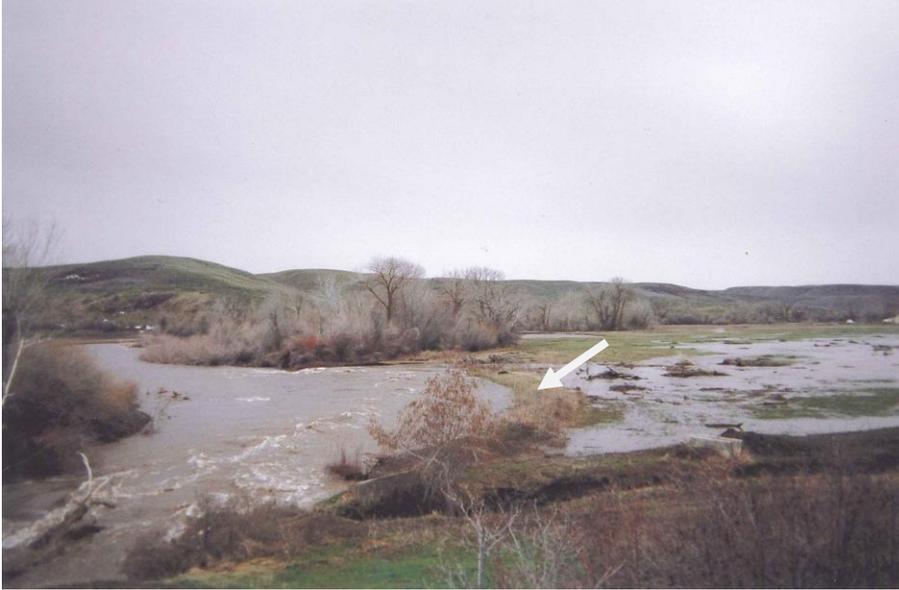
BEFORE:

Spring flooding 2006- Note debris in field

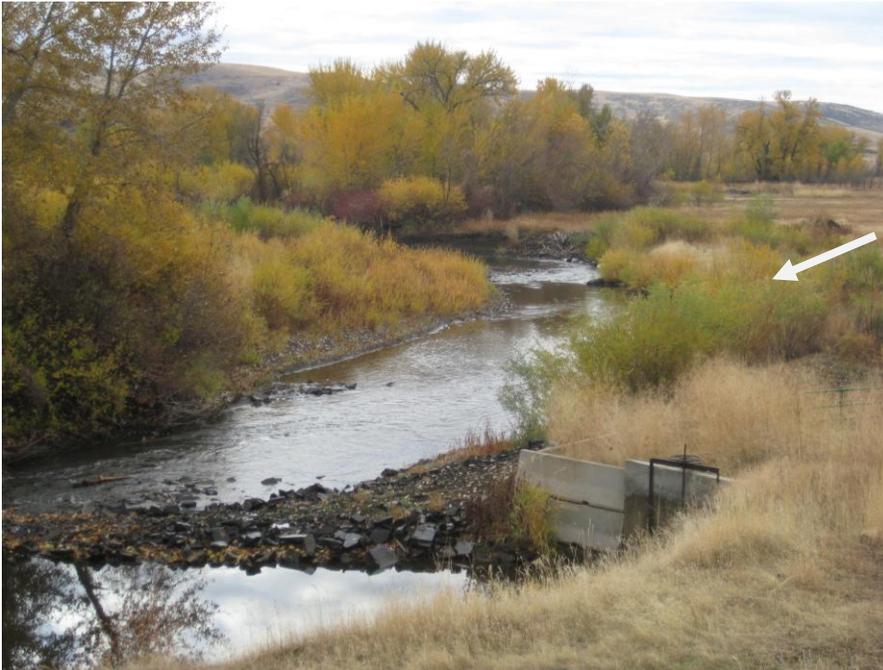
AFTER:

Willow growth in same area- Fall 2012

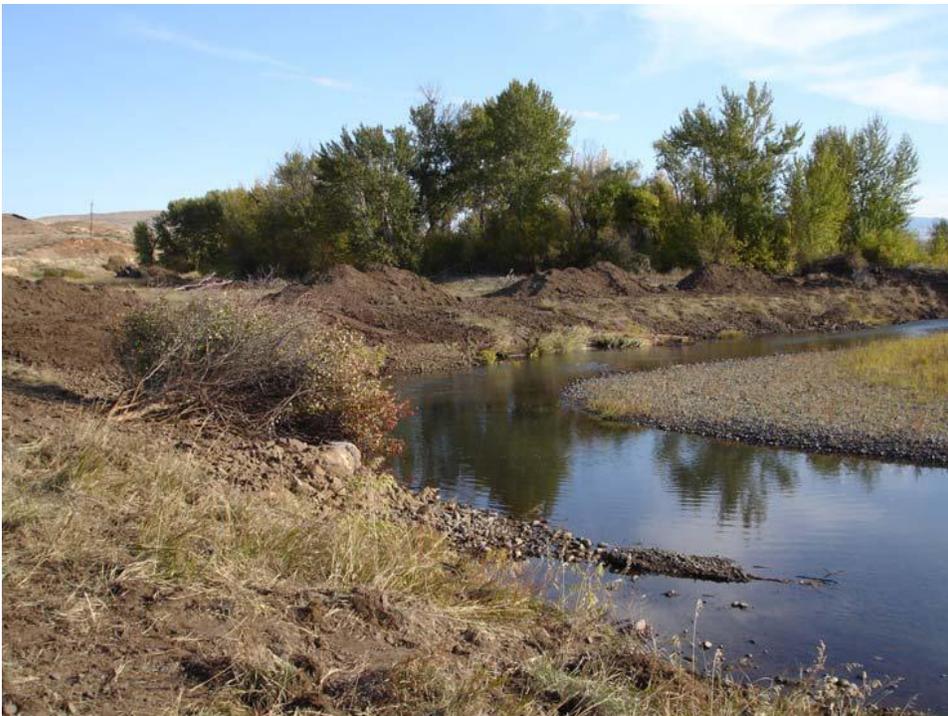
AFTER:

Banks sloped back

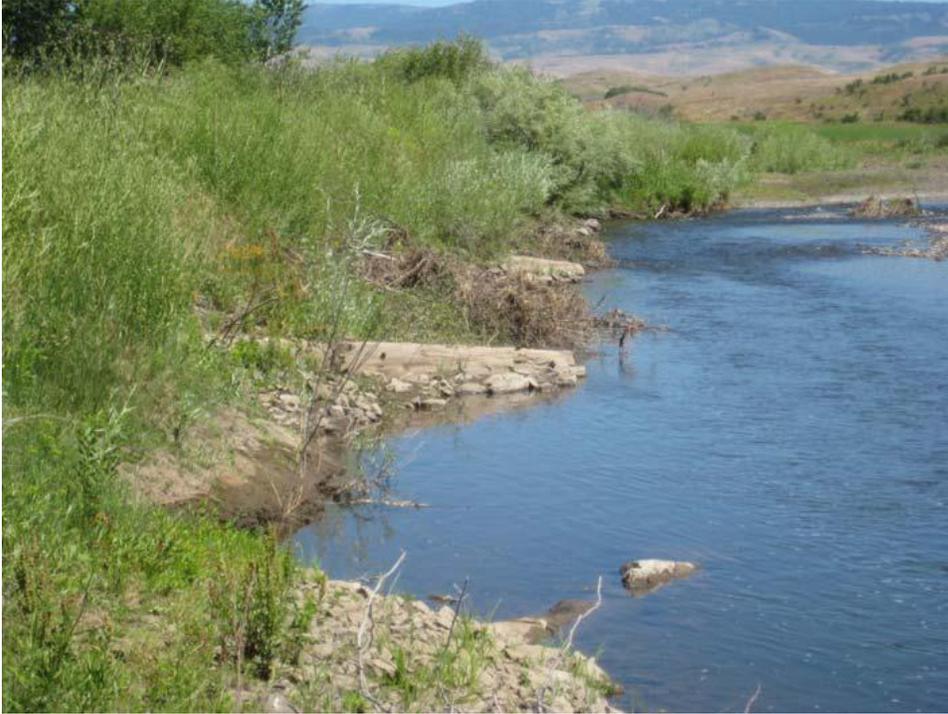
AFTER:

Early summer 2010- some sediment deposition, willow growth (same site as above 3 photos)

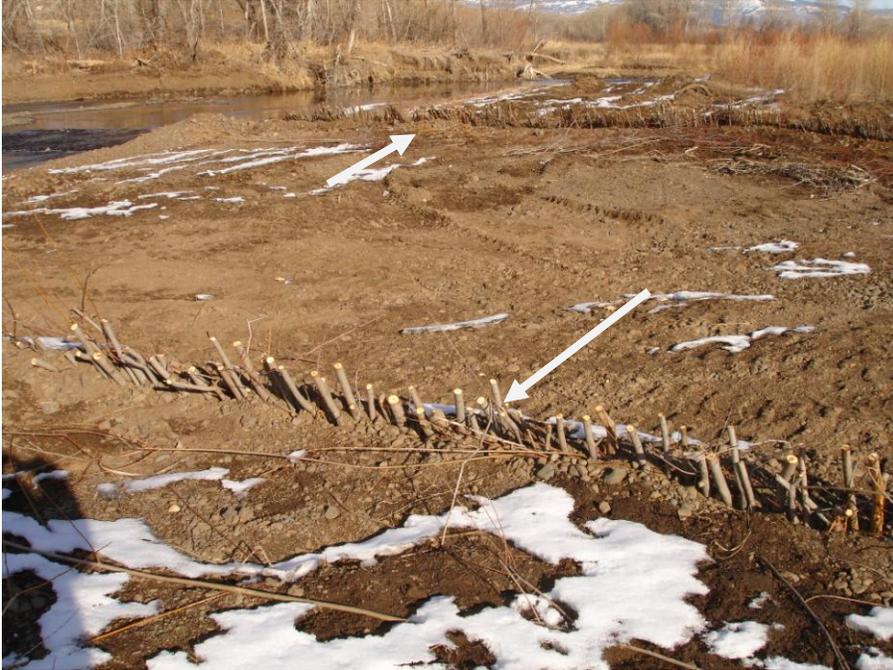
Willows placed in trenches, buried several feet deep and cut off

This project treated 2,225 feet of stream bank by installing rock and log barbs and establishing riparian vegetation. About 30 willow clumps and hundreds of stems were planted in the riparian area. This project utilized willow trench packs, which proved very successful, if labor intensive.

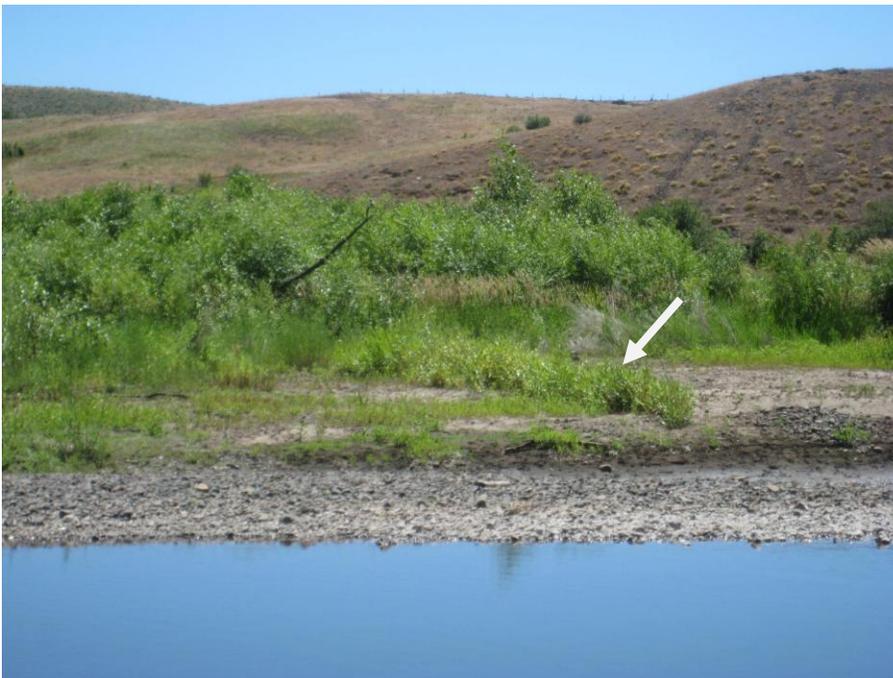
Same willow trench pack the following summer

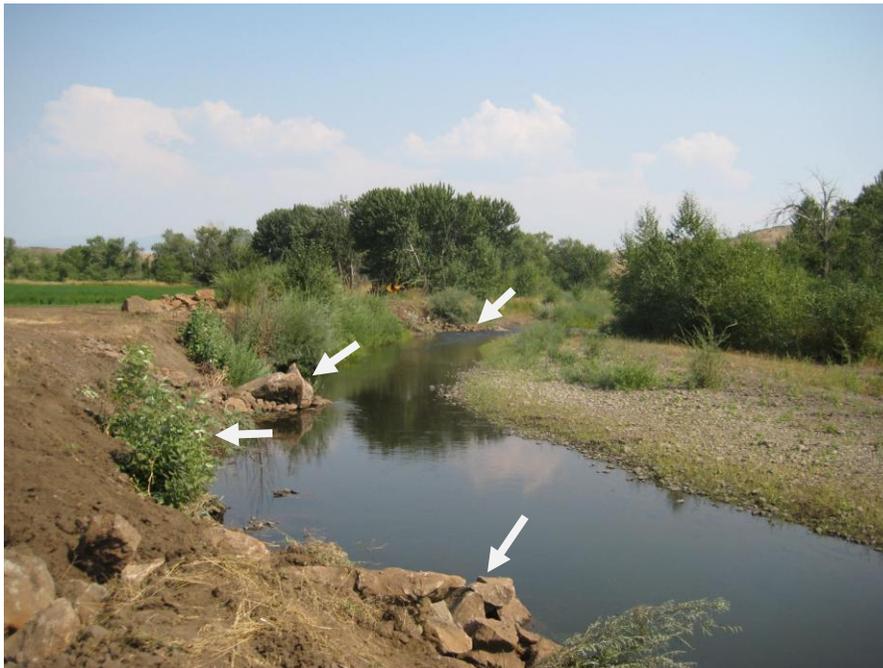
Upper project area-Summer 2011

This project treated 2,225 feet of stream bank by installing rock barbs and establishing riparian vegetation. Several hundred willows were planted in the riparian area. This site has large areas what have been historically straightened. While there is good willow growth and some meanders are beginning to establish, this entire area is likely to require more treatment in the future as the stream continues to seek new meanders.

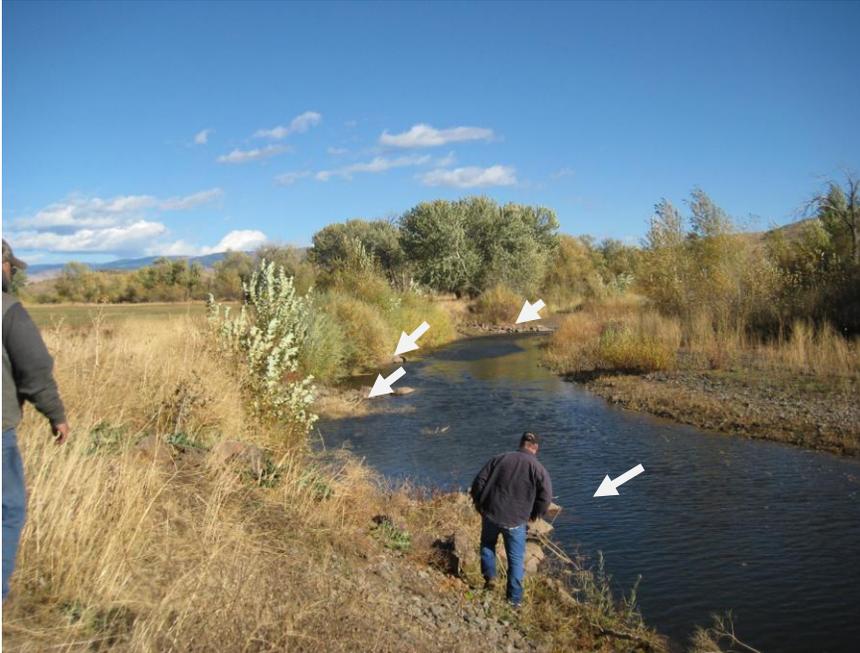
Upper project site Fall 2012- Several barbs and plantings with good deposition

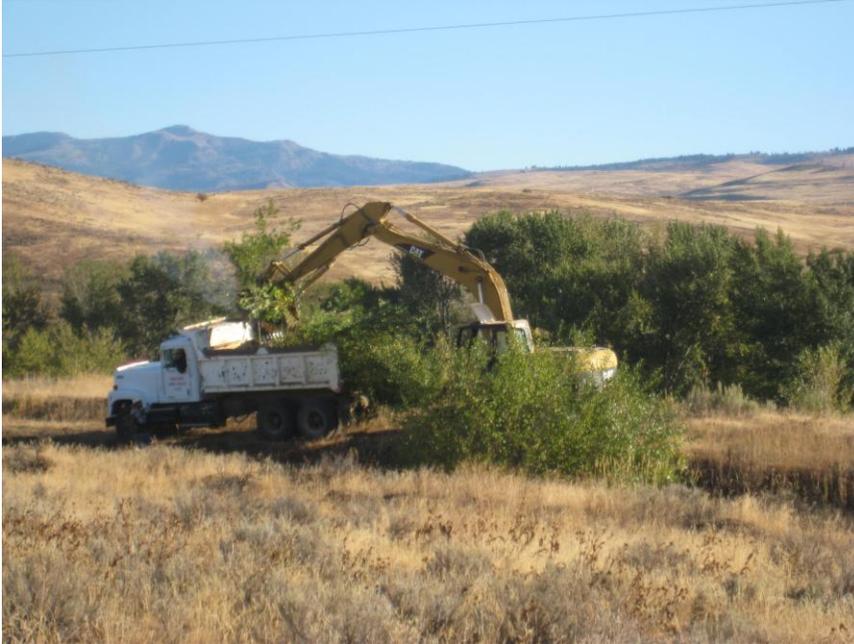
Loading willow clumps for transplanting

In the fall of 2010, the Little Weiser Irrigation District planned to clean about a three-quarter mile section of the inlet canal to the C Ben Ross Reservoir. There were hundreds of live willow clumps that otherwise would have been discarded. Adams SWCD asked to partner with the Irrigation District by paying for half the cost of the track hoe if landowners could have the willows for their river projects. The District agreed and two landowners hauled about 10 truckloads of willows clumps to several project sites. The estimated value of these willows was at least \$4,000.00.
